EBT SAND

TAP HOLE INSPECTION
AND SAND FILLING

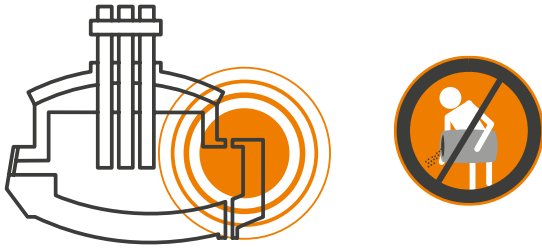
The on-board solution to inspect and fill sand is a compact all-in-one design equipment assembled on a sliding guide. A local small bin is charged with the proper amount of sand by a small stationary dispenser, located close to the furnace. The inspection camera is mounted parallel to the feeding chute in order to check in real time the correct feeding of the material and tap hole status.
