AUTOSAND

TAP HOLE INSPECTION
AND SAND FILLING

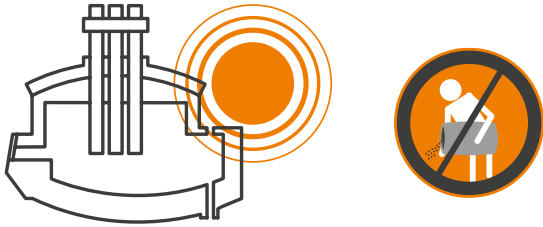
Specifically developed for off-board installation in case of reduced space availability on sump area or frequent shell change practice to inspect and sand fill.

The inspection camera is mounted parallel to the feeding pipe in order to check in real time the correct feeding of the material and tap hole status.

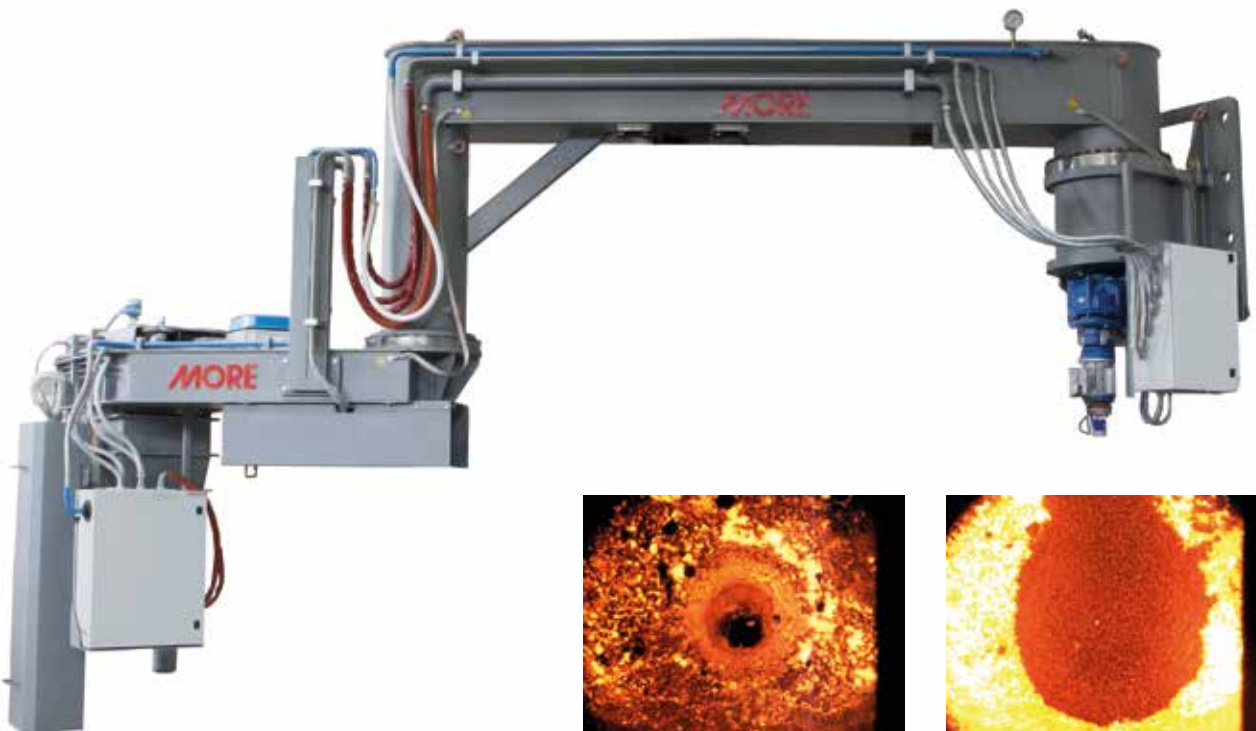
EBT AFTER
TAPPING

EBT POST
SANDING
